# **Aquatic Plant Management Plan**

## **Minocqua and Kawaguesaga Lakes**

**2008**

Prepared by: Ecological Integrity Service, LLC and the  
Minocqua-Kawaguesaga Lakes Aquatic  
Plant Management Committee

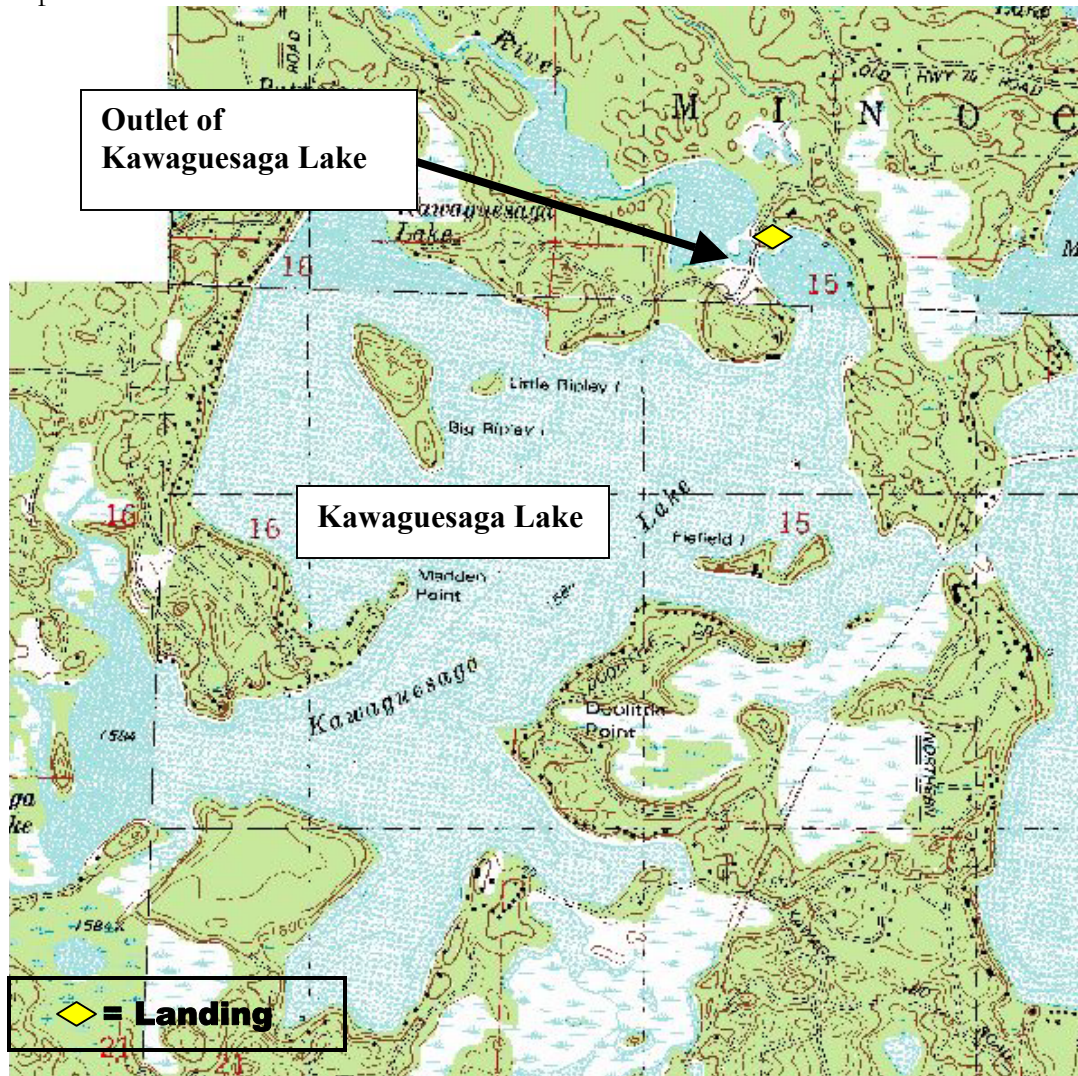
*Figure 1: Topographical map of Kawaguesaga Lake*

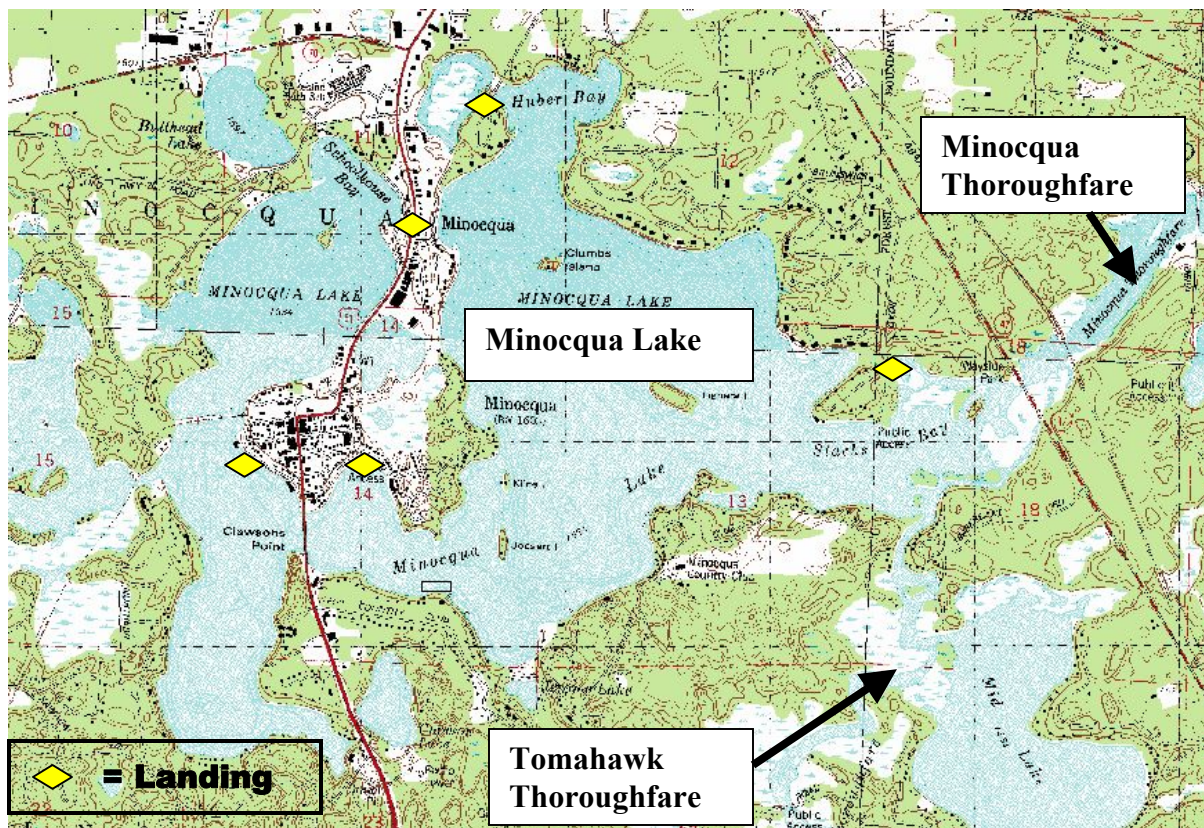
*Figure 2: Topographical map of Minocqua Lake*

This plan includes waters outside of the Minocqua Lake proper. They include the Minocqua Thoroughfare (see labeled in Figure 2). Also a portion of the Tomahawk Thoroughfare is included. Figure 3 shows the cutoff for the boundary of this plan. The bridge at Thoroughfare Road is the landmark that ends the coverage of this plan.

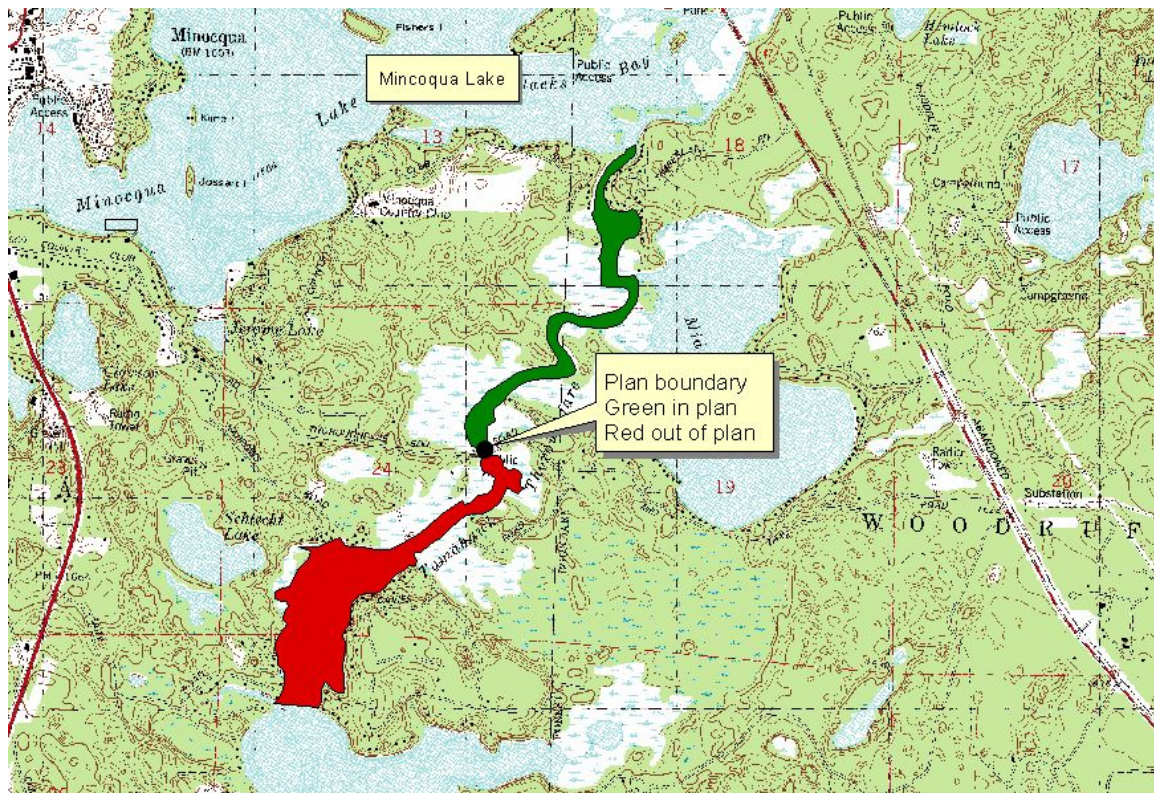
Figure 3: Boundary of this plan in the Tomahawk Thoroughfare.

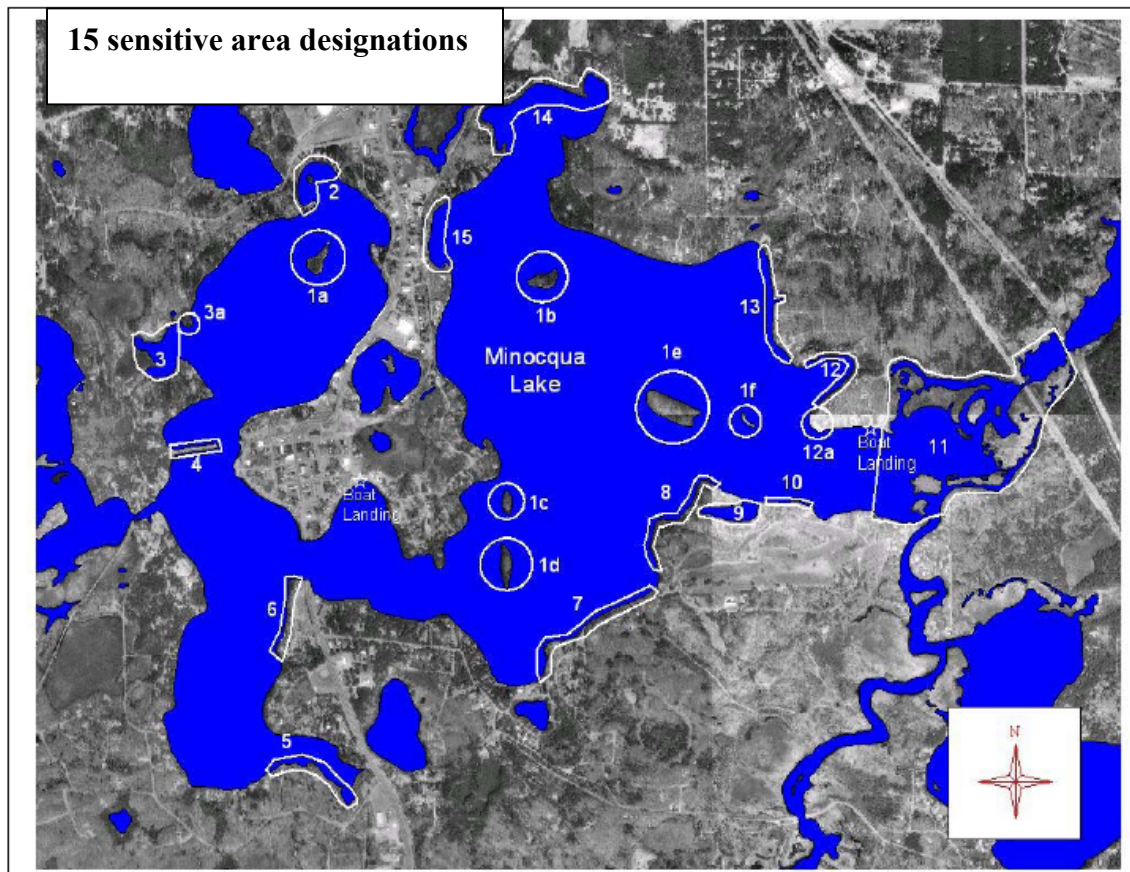
**Figure 4: Map of designated sensitive areas Minocqua Lake**

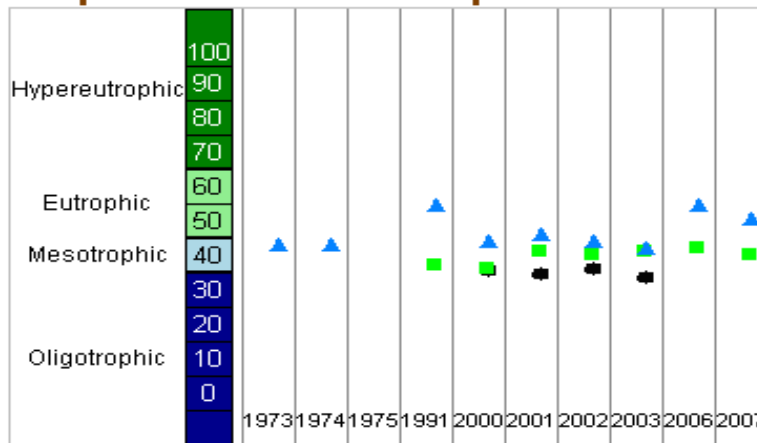
**Monitoring Station: KAWAGUESAGA LAKE - DEEP HOLE,**  
Past Summer (July-August) Trophic State Index (TSI) averages.

**Figure 5: Trophic State Index Graph-Kawaguesaga Lake 1973-2007**

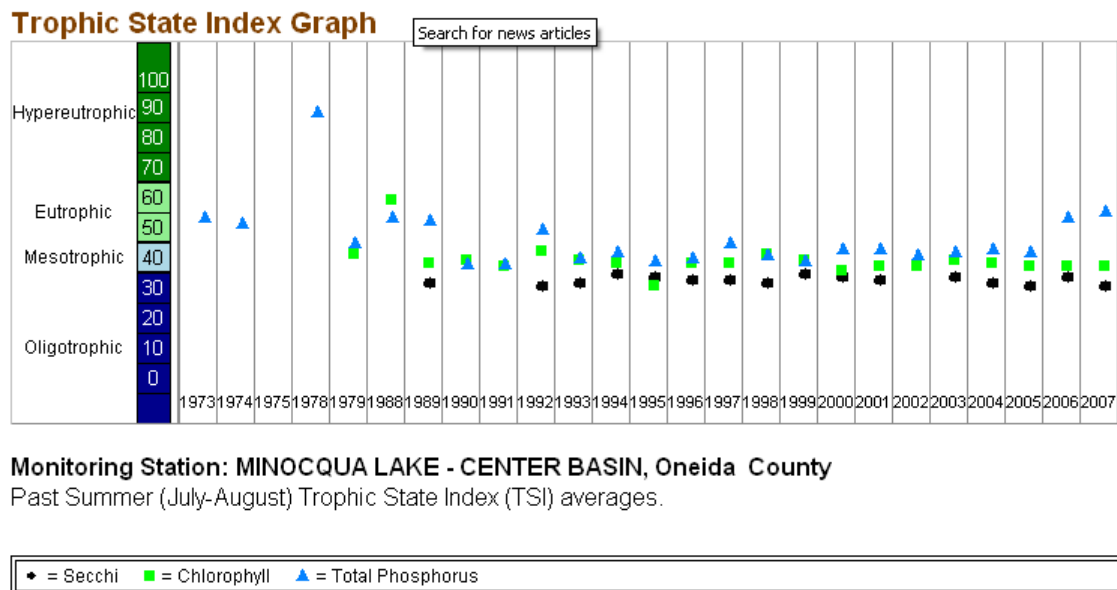
**Figure 6: Trophic State Index Graph-Minocqua Lake 1973-2007.**

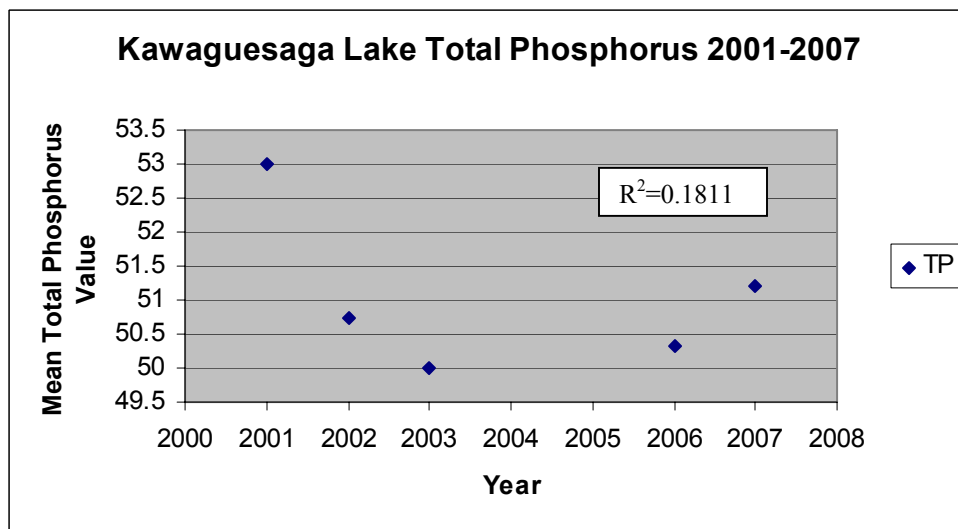
**Figure 7: Total Phosphorus trends for Kawaguesaga 2001-2007**

The trend lines for phosphorus are not necessarily valid. For Kawaguesaga Lake, there appears to be a slightly downward trend in total phosphorus since 2000. However the correlation is low and therefore this potential trend should be used with caution. As for Minocqua Lake, the total phosphorus readings since 1998 have been very erratic with no real correlation to a trend (although the trend line appears to be decreasing slightly).

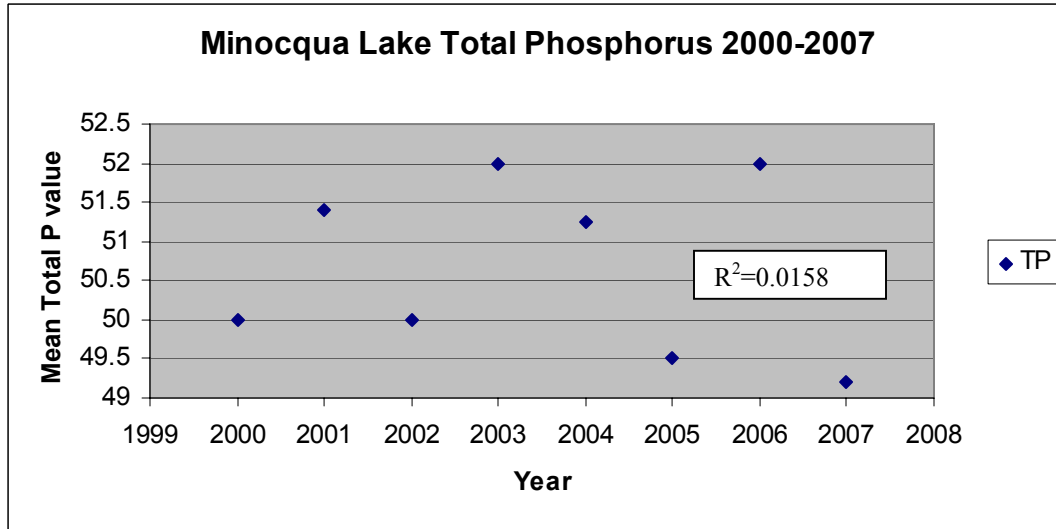
Figure 8: Total phosphorus trends Minocqua Lake 1998-2007

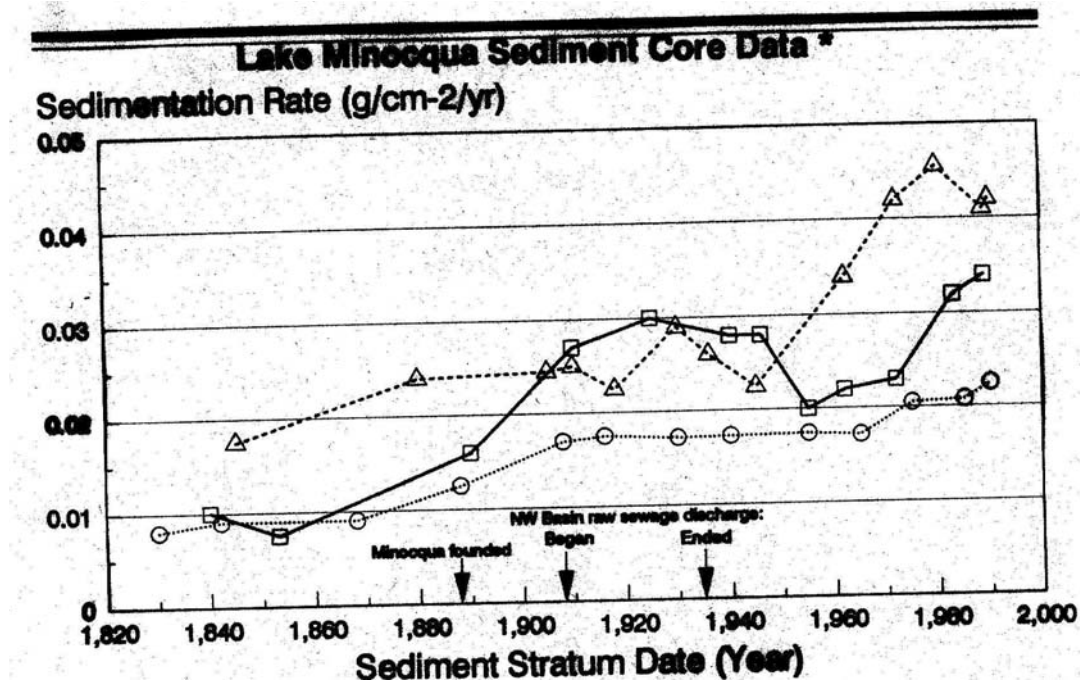
Recently sediment cores were obtained and analyzed for historical sedimentation rates. The results suggest that sedimentation rates were relatively stable for many decades until about 40 years ago. From that point on, the sedimentation rates have increased immensely. This is most likely due to increased development on and near Kawaguesaga Lake and Minocqua Lake during the last few decades<sup>7</sup>.

Figure 9: Sediment core graph<sup>8</sup>. Line differences are unknown.

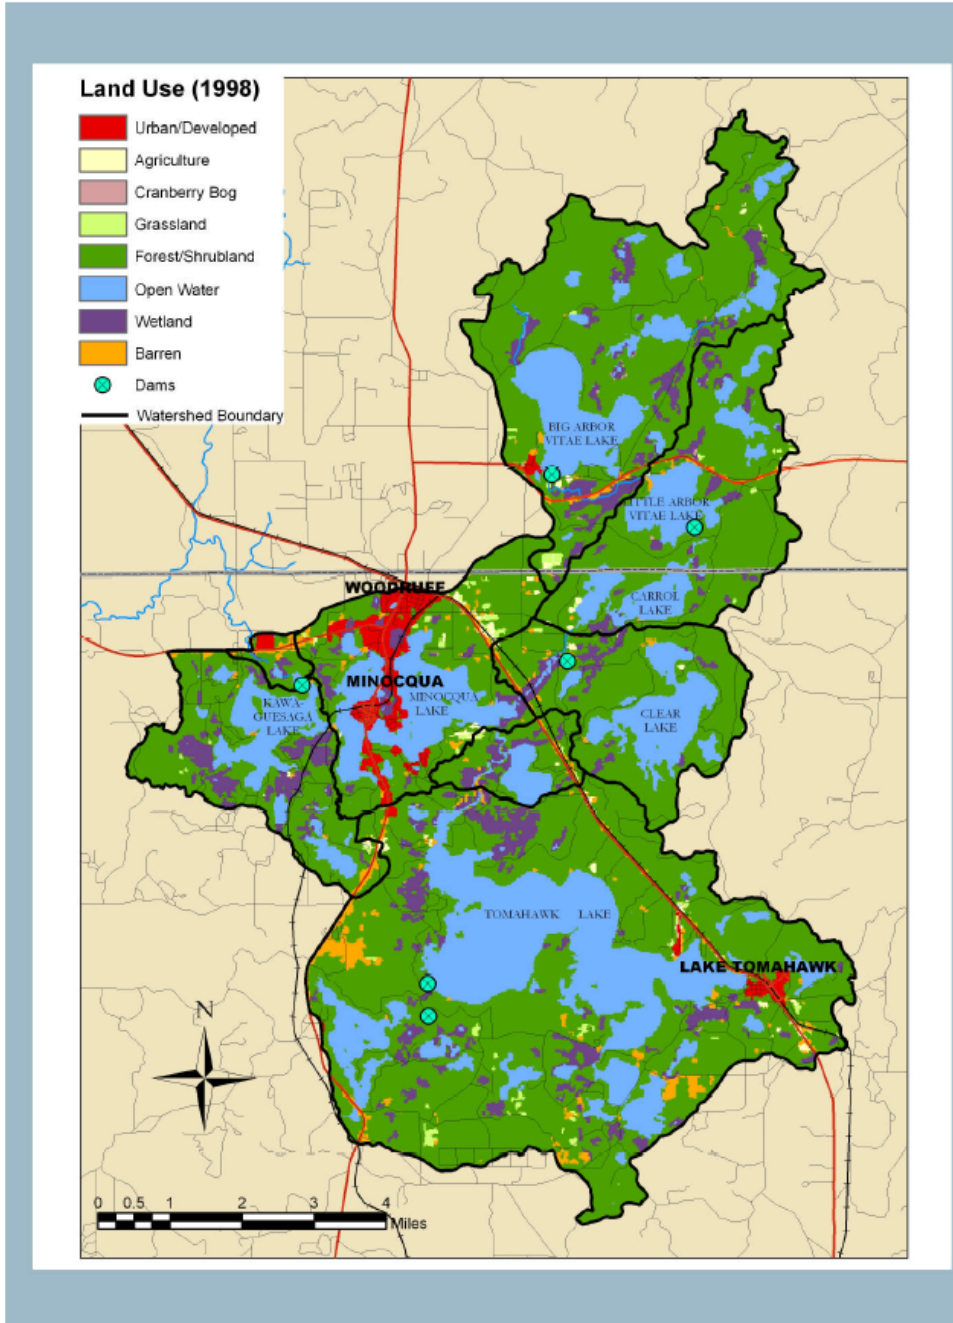
The watershed for Kawaguesaga/Minocqua Lakes is very extensive when considering all water sources. The land cover map indicates that the vast majority of land cover in the watershed is forested.

**Figure 10: Map of Minocqua Chain watershed with land cover.**

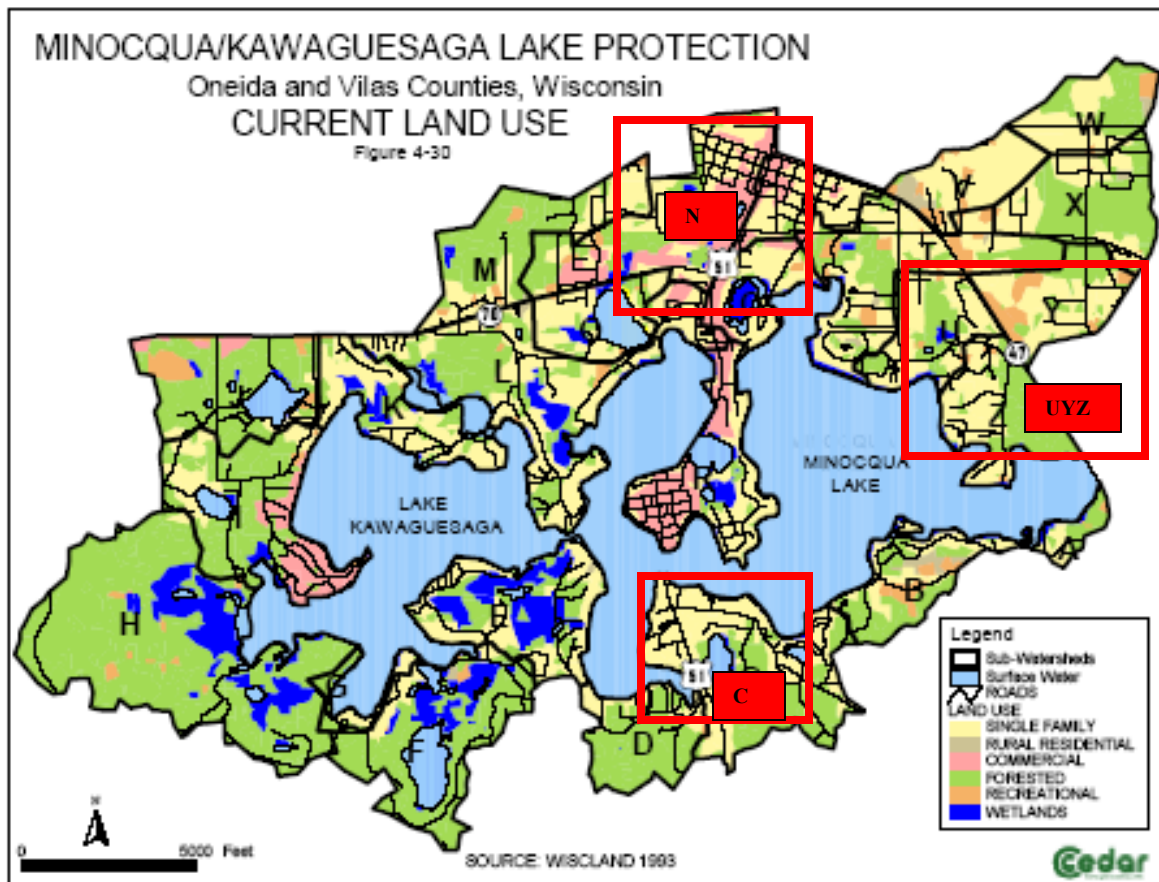
In the immediate watershed, it is evident that various land uses are having varying impacts on the lakes. Observed on the map, there is extensive urban development adjacent to these lakes. Furthermore, single-family residential development in the riparian zone is extensive. As a result, the runoff volume and nutrient content of the runoff increases. Native vegetation that would normally remove sediments and nutrients from the runoff is replaced with lawns and/or impervious surfaces. The runoff increases in volume and little or no sediment is removed. The result is phosphorus-bound sedimentation into the lakes, which increases phosphorus concentrations and allows more plant and algae production.

Figure 11: Current land use (1993) for Kawaguesaga and Minocqua Lakes.

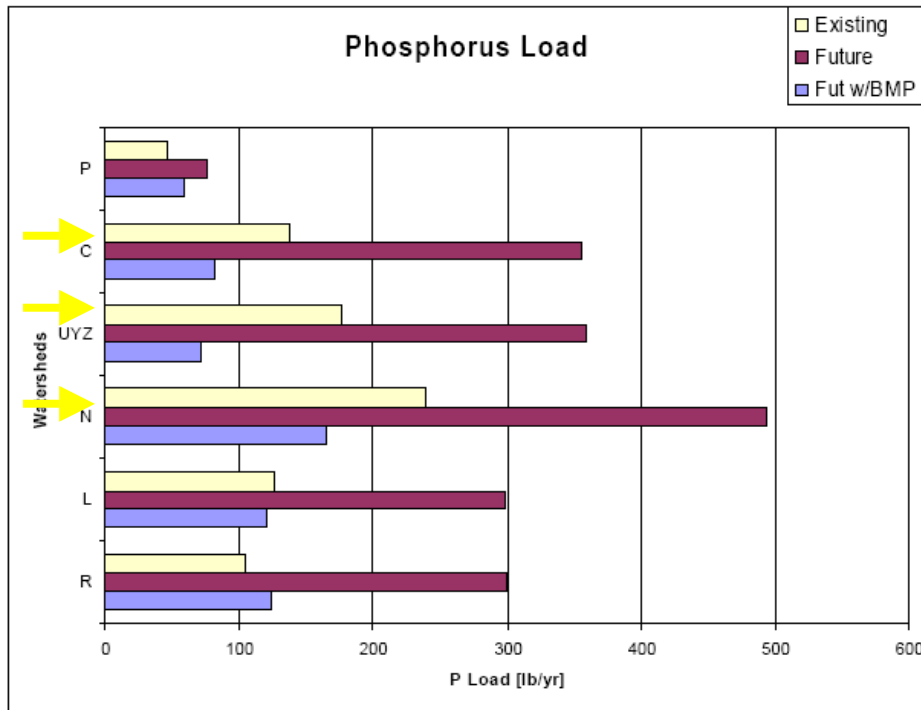
**Figure 12: Phosphorus loading (lb/yr) by watershed (highest 3 marked).**

The future landuse predictions show that all of these (as well as others) may increase phosphorus loading significantly, with N reaching nearly 500 lbs per year.

Sub-watersheds L, P and R are also significant contributors. All of these watersheds, along with C and N are adjacent to dense EWM stands. This nutrient influx can contribute to high nutrient sediments and exacerbate EWM growth.

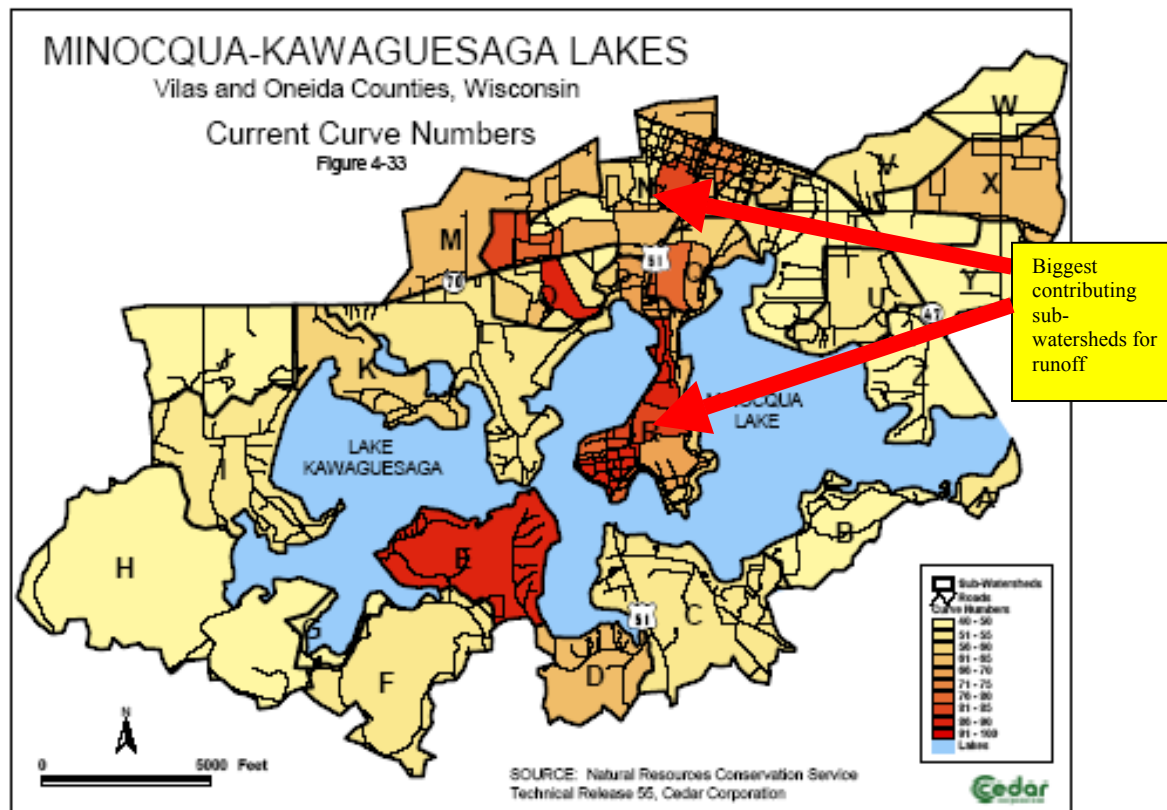
**Figure 13: Runoff curve numbers from Natural Resources Conservation Service. Darker shades provide more runoff.**

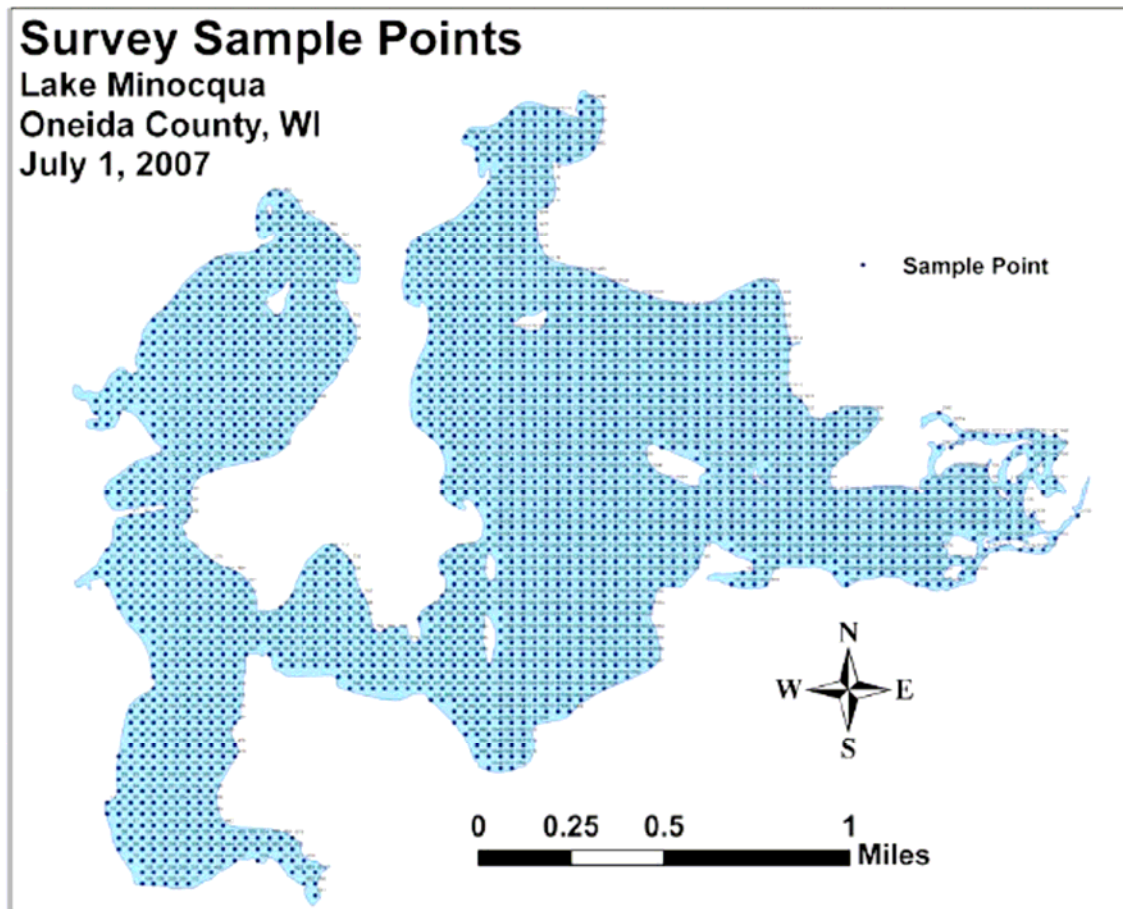
The Lake Minocqua grid contained 2,153 points. Of the total, 917 points were 20 feet deep or less, and thus could support plant growth (littoral zone).

**Figure 14: Sample point grid for Minocqua Lake.**

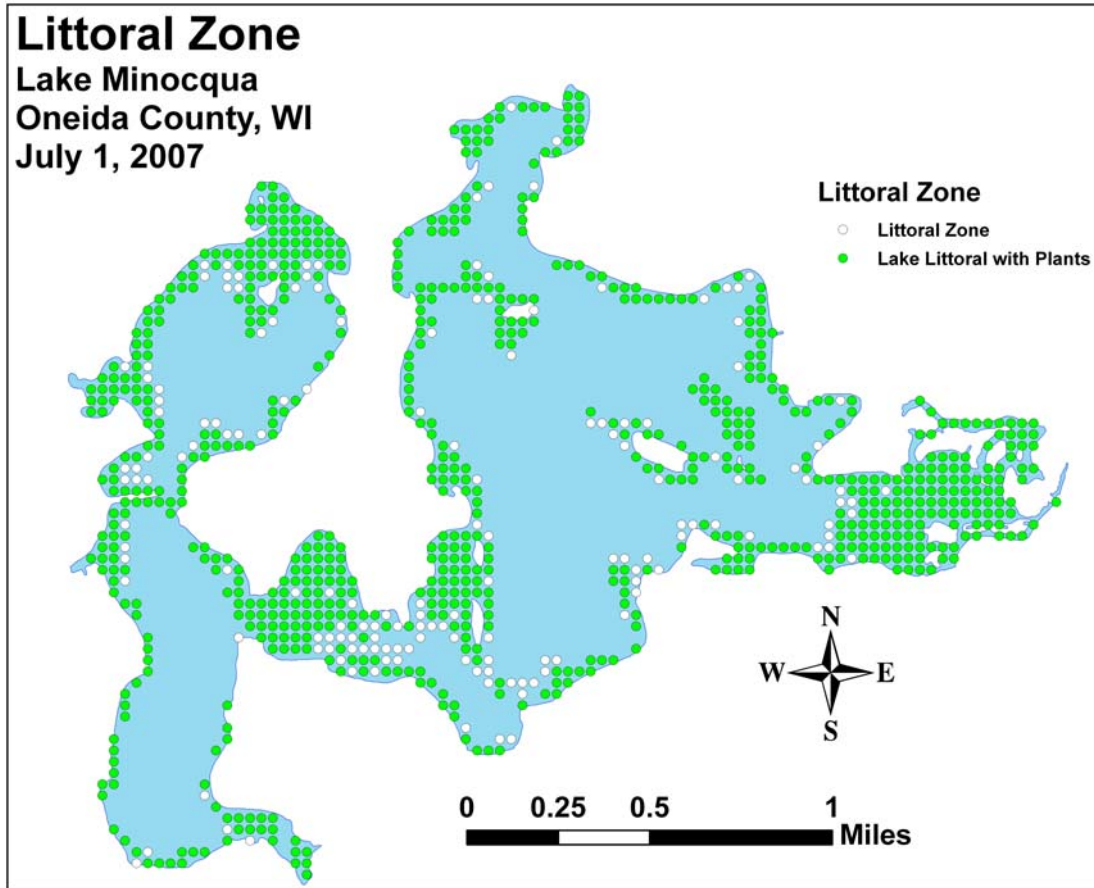
**Figure 15: Minocqua Lake littoral zone and points in littoral zone with plants.**

In Lake Minocqua, plants were found growing on approximately 37% of the entire lake bottom, and 87% of the littoral zone. Diversity was extremely high with a Simpson Diversity Index value of 0.94. Species richness was also high with 54 total macrophyte species (including filamentous algae) found growing in and immediately adjacent to the lake that were sampled. The majority of aquatic macrophytes were found growing in water with an average depth of 8ft. At these depths, there was high diversity and evenness with no one species dominating. Although we determined the littoral zone out to 20 feet, in most parts of Lake Minocqua, the “weedline” ended at 17ft. Coontail (*Ceratophyllum demersum*), Robbins (fern) pondweed (*Potamogeton robbinsii*), flat-stem pondweed (*Potamogeton zosteriformis*), and small pondweed (*Potamogeton pusillus*) were the most common species being found at 51.64%, 37.91%, 37.28% and 30.23% of the survey points with vegetation respectively.

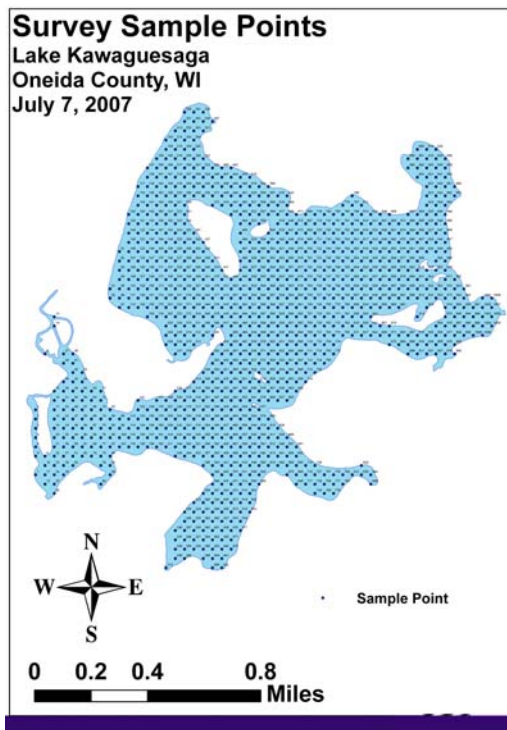
The Lake Kawaguesaga grid contained 1,009 points. Of the total sample points, 577 points were 18.5 feet deep or less, and thus could support plant growth (littoral zone). Kawaguesaga's western (muck and boggy) bays supported high plant diversity.

Figure 20: Sample point grid for Kawaguesaga Lake

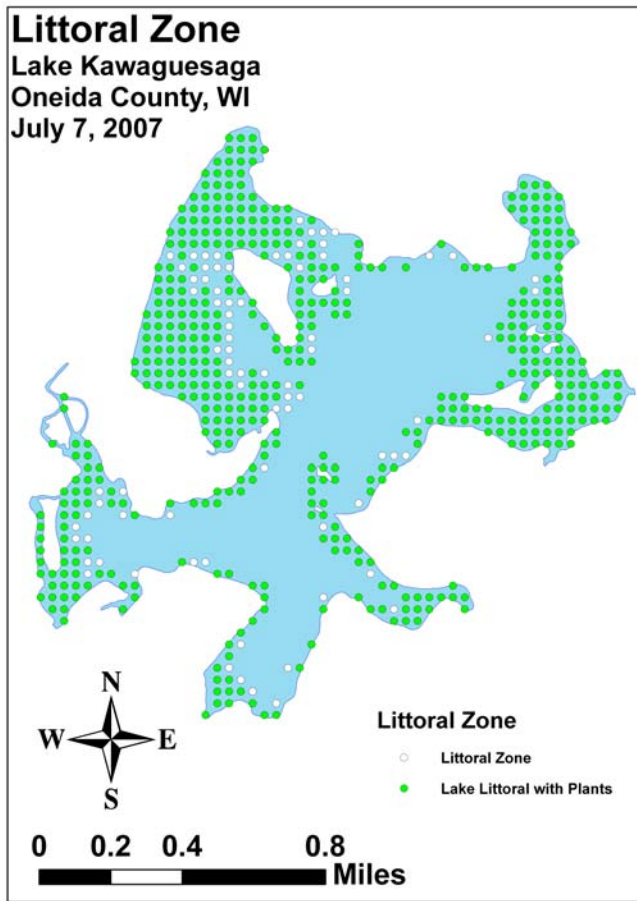
**Figure 21: Points with plants in littoral zone Kawaguesaga Lake**

In Lake Kawaguesaga, plants were sampled growing on approximately 49% of the entire lake bottom, and 86% of the littoral zone. Diversity was extremely high with a Simpson's Diversity Index value of 0.93. Species richness was also high with 50 total macrophyte species (55 including viewed) found growing in and immediately adjacent to the lake. The majority of aquatic macrophytes were found growing in relatively deep water with an average depth of almost 10ft. These 12-18ft. areas of Kawaguesaga Lake, especially the flats surrounding Big and Little Ripley Islands in the northwest bay, were dominated by four species: Coontail, flat-stem pondweed, small pondweed, and Robbins (fern) pondweed. These plants were found at 44.85%, 44.85%, 42.42% and 36.36% of survey points with vegetation respectively.

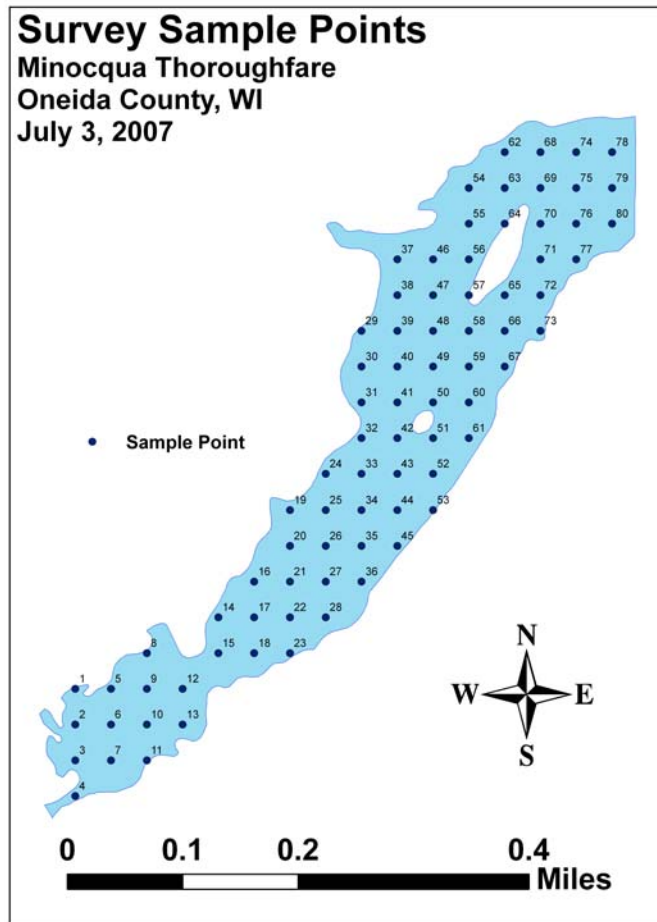
The Minocqua Thoroughfare grid contained only 80 points, and none of them were over 8ft deep. The substrate was organic muck throughout, and plants were located at all points.

*Figure 26: Sample point grid-Minocqua Thoroughfare*

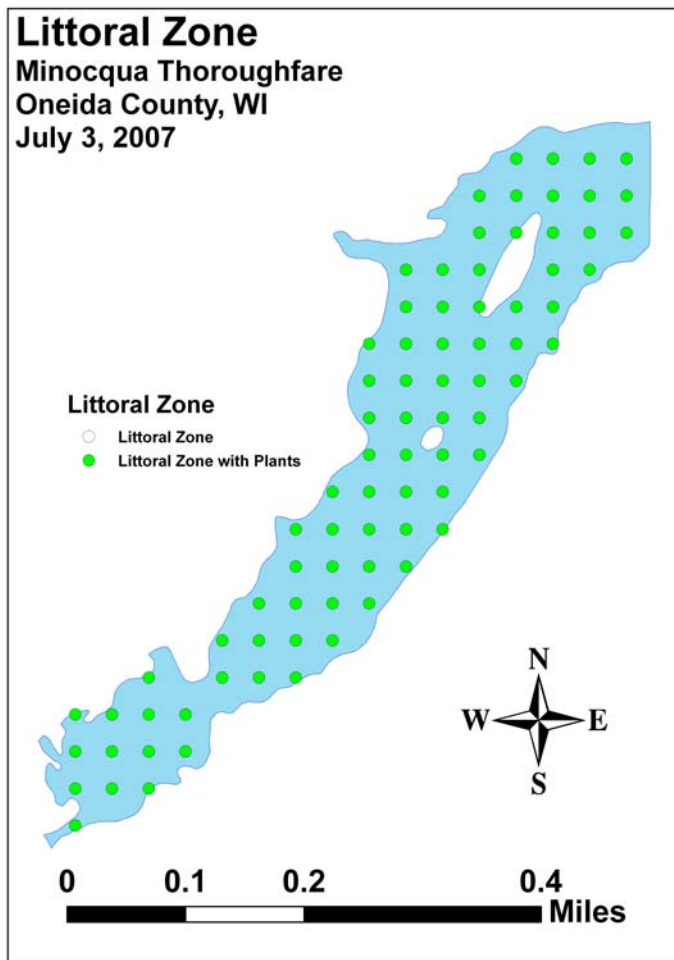
**Figure 27: Points with vegetation in littoral zone-Minocqua Thoroughfare**

In the Minocqua Thoroughfare, plants were sampled at 100% of the survey points. Somewhat surprisingly, diversity was similar to the two large lakes with an extremely high Simpson Diversity Index value of 0.93. There were 42 (43 with viewed) species found here, which is lower than the two lakes, but still very high diversity. The reduction in diversity is likely due to a single bottom type and a smaller total area. Plant density was greater here than at any other point in the chain. It was a struggle to get to many sites as the plants had canopied or the site was actually in the middle of a cattail “forest”. Coontail was again the dominant species being found at 70.00% of the sites. Common waterweed (*Elodea canadensis*), flat-stem pondweed, and forked duckweed (*Lemna trisulca*) represented the three other most frequently encountered species being found at 66.25%, 42.50%, and 26.25% of survey points respectively.

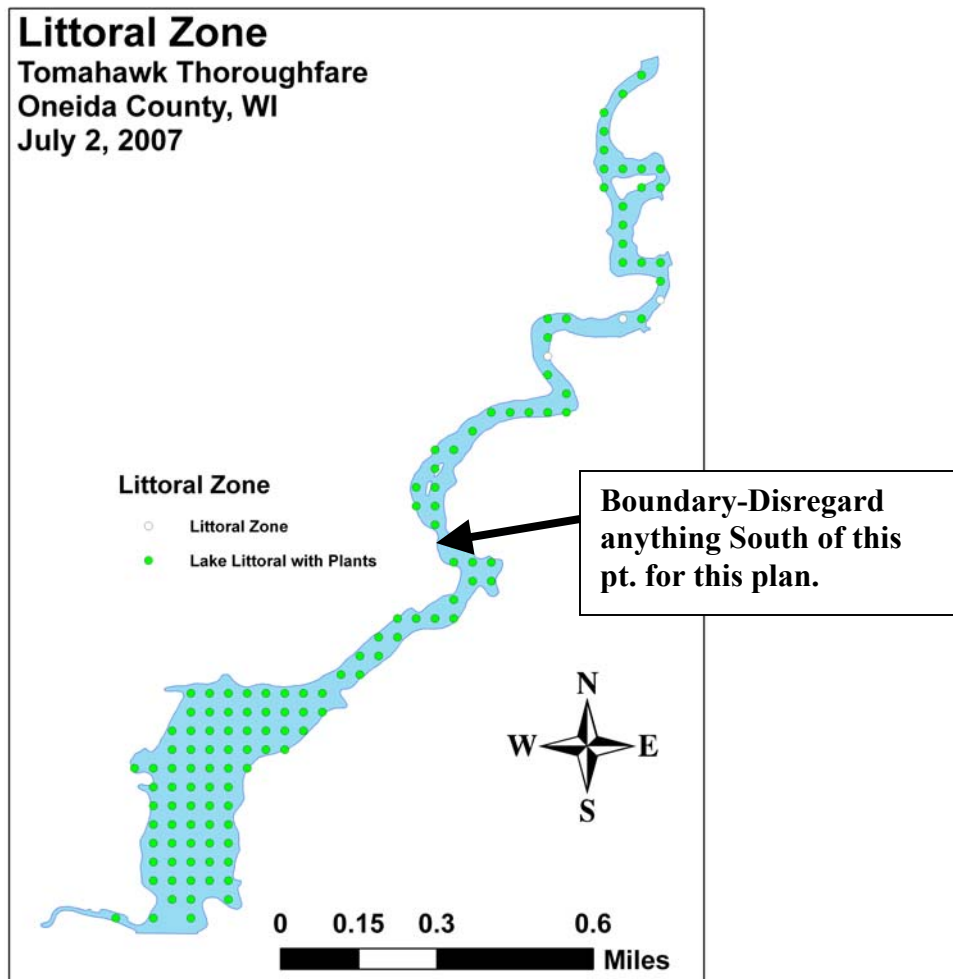
The Tomahawk Thoroughfare grid contained 134 points, and all the points were located in water <13ft. deep. The bottom was primarily muck, but some rocky areas increased diversity; plants were found at almost all sites.

**Figure 31a: Sample points and points with vegetation in littoral zone-Tomahawk Thoroughfare. Note the location of the boundary for this plan. All points south are not part of this plan.**

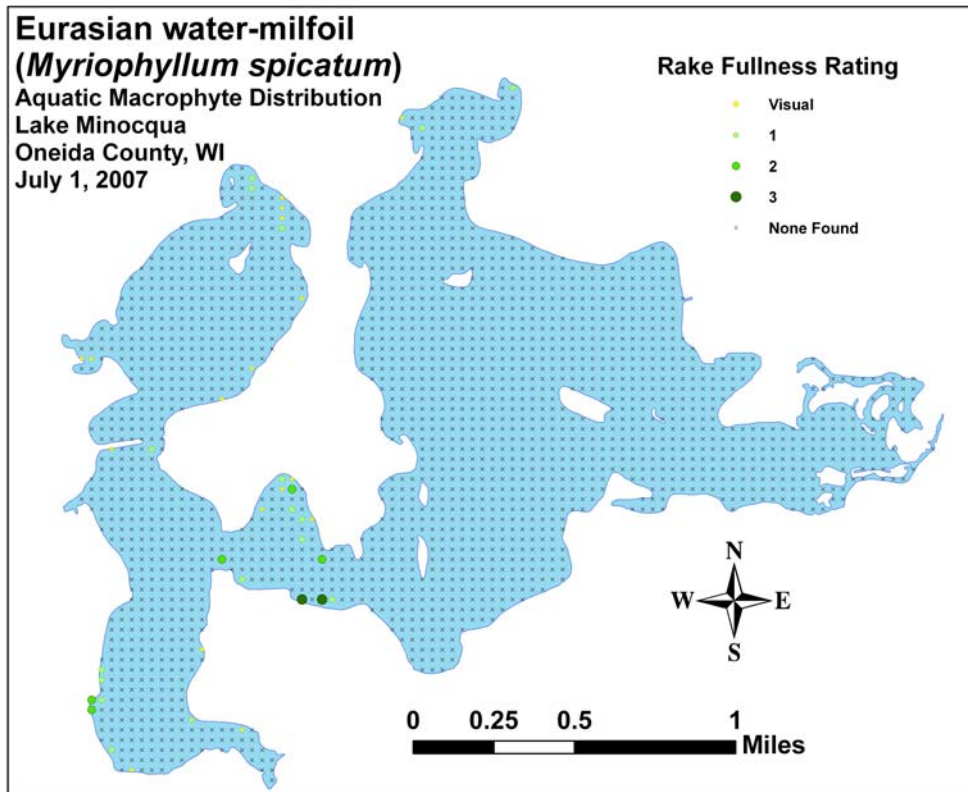
During the point intercept survey, Eurasian water milfoil was found scattered throughout the western half of Lake Minocqua. The denser stands occurred in Kennedy Bay near the boat landing and on the shoreline directly across from the landing. From these areas near the Hwy-51 bridge, plants have spread to all nearby bays. The north end of School House Bay, and the west end of South Bay had particularly large stands that indicate original satellite plants arrived there several years ago. Single plants were located on a regular basis among the extensive beds of northern water milfoil that grows in approximately 7 feet of water throughout the western side of the lake. No beds or individual plants were located in the eastern 1/2 to 1/3 of the lake all the way to the thoroughfares although there are many places that would provide ideal habitat. Curly-leaf pondweed (*Potamogeton crispus*), purple loosestrife (*Lythrum salicaria*), flowering rush (*Butomus umbellatus*), and reed canary grass (*Phalaris arundinacea*) were also distributed around and in Lake Minocqua.

Figure 36: Map of Eurasian water milfoil distribution-Minocqua Lake

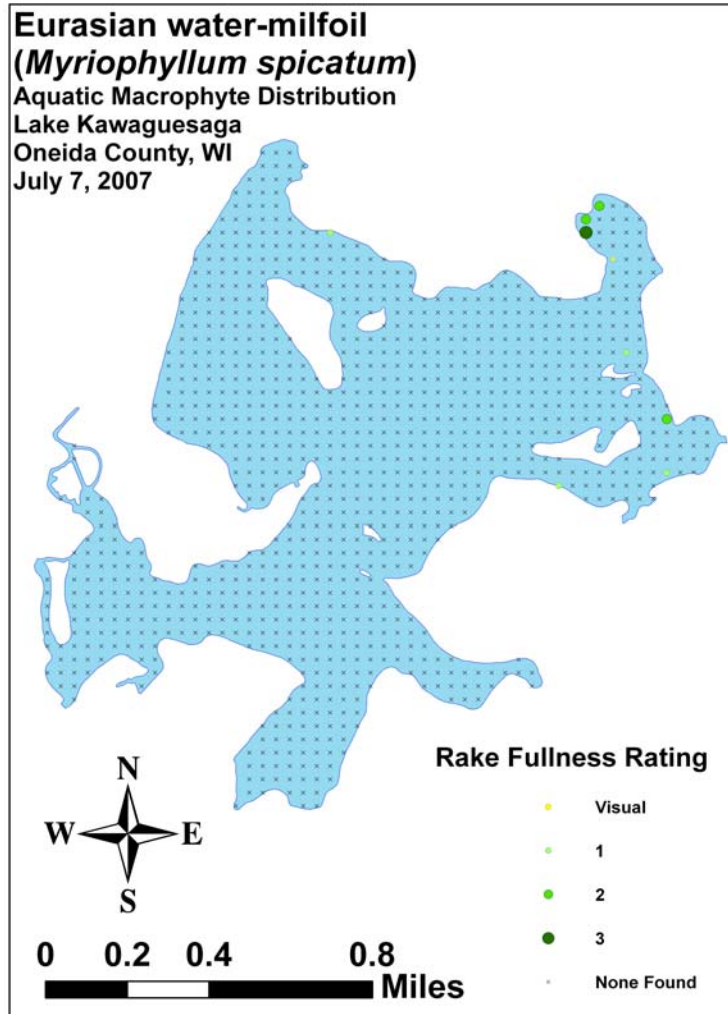
Figure 40: Map of Eurasian water milfoil distribution-Kawaguesaga Lake

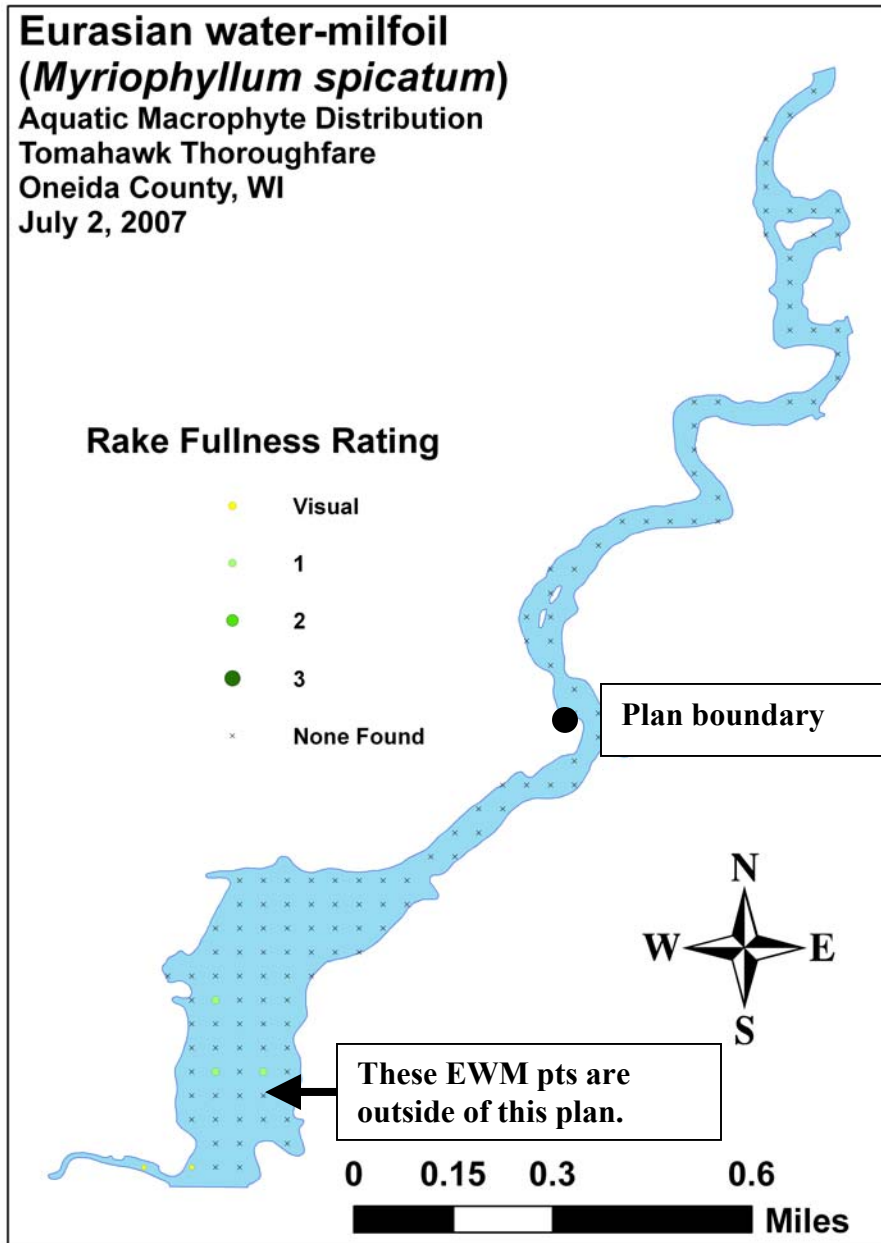
Eurasian water milfoil was abundant at certain locations on the south end of the Tomahawk Thoroughfare; especially in 6 feet of water near point 10 by the boat dock through point 17 by the boat-in restaurant. However, all EWM sites fall outside of the boundaries for this plan. Curly-leaf pondweed, Purple loosestrife, Flowering rush, and Reed canary grass were also distributed around and in the Tomahawk Thoroughfare. Purple loosestrife and Flowering rush were most common in the north end where they were occasionally abundant in mixed stands with cattails (*Typha* sp.).

Figure 45: Map of Eurasian water milfoil distribution-Tomahawk Thoroughfare

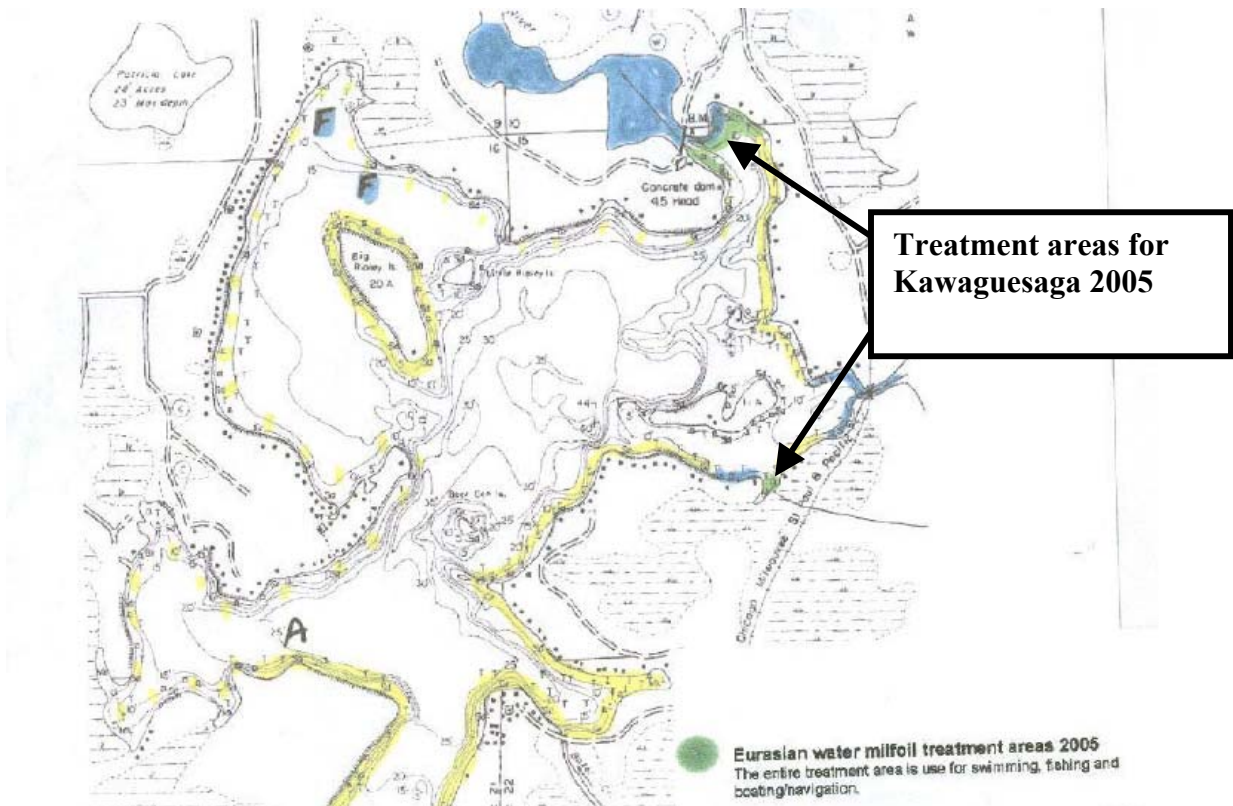
In July 2005, after Eurasian water milfoil was determined to be present, a permit was granted to chemically treat 25.5 acres for EWM on Kawaguesaga Lake and Minocqua Lake. The treatment was with 2,4-D at the locations highlighted on the map below.

**Figure 53: Map of EWM treatment locations-Kawaguesaga Lake, 2005**

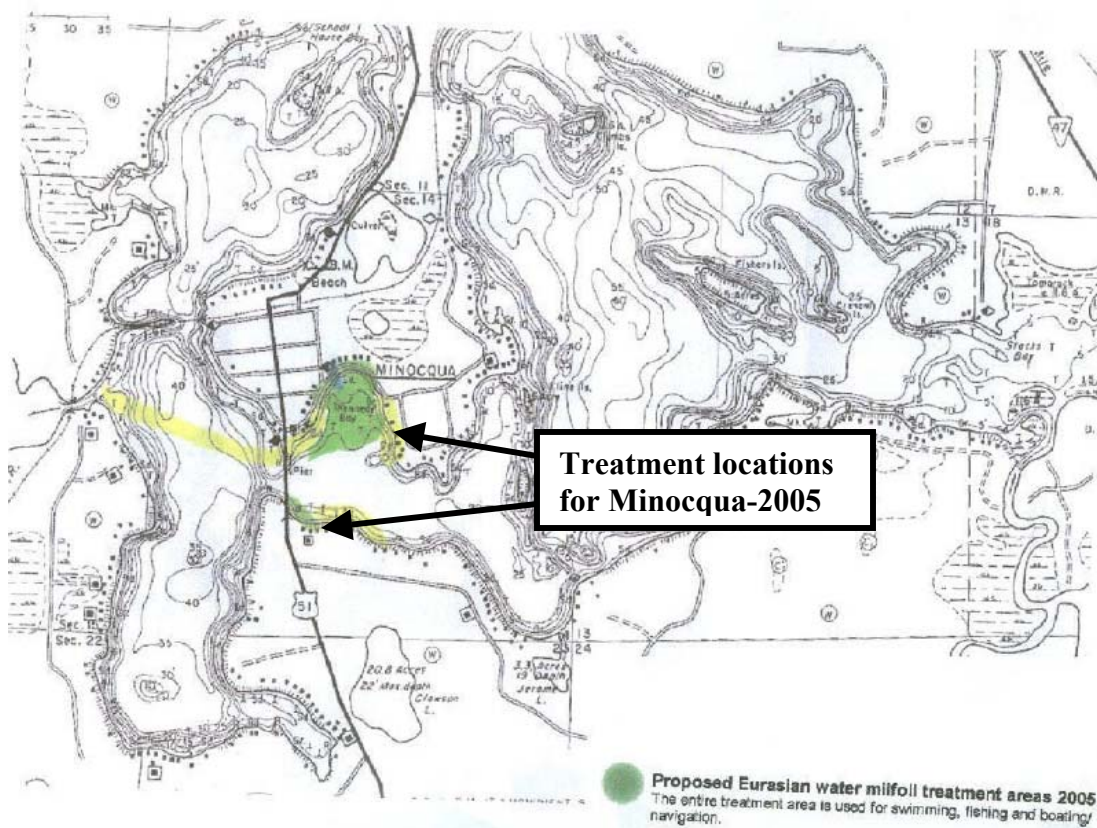
**Figure 54: Map of EWM treatment locations-Minocqua Lake, 2005**
