# **Aquatic Plant Management Plan**

## **Minocqua and Kawaguesaga Lakes**

**2008**

Prepared by: Ecological Integrity Service, LLC and the  
Minocqua-Kawaguesaga Lakes Aquatic  
Plant Management Committee

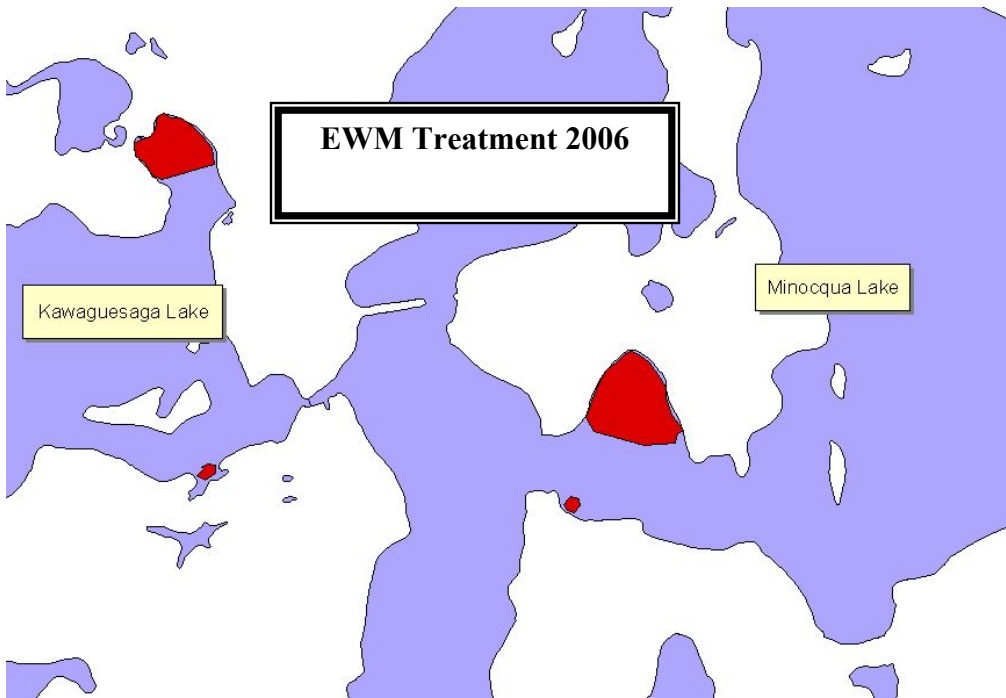
**Figure 55: EWM treatment sites-2006**

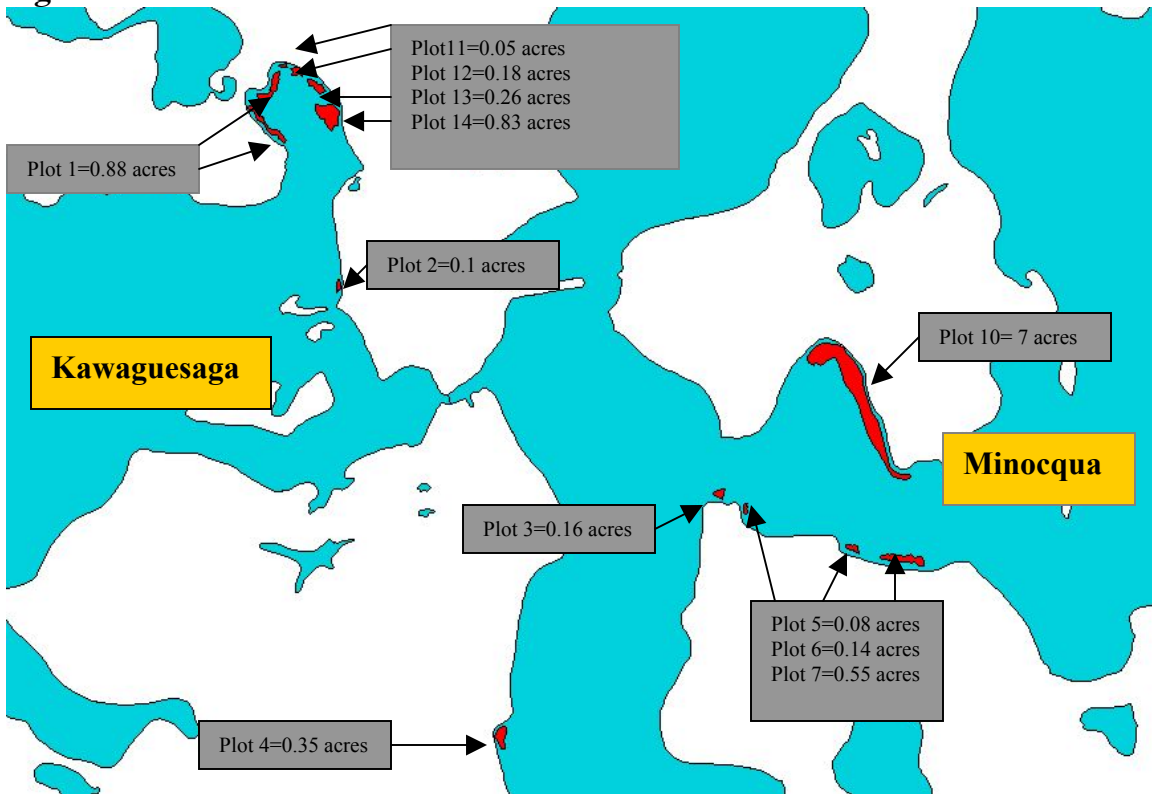
**Figure 56: EWM treatment sites-2008**

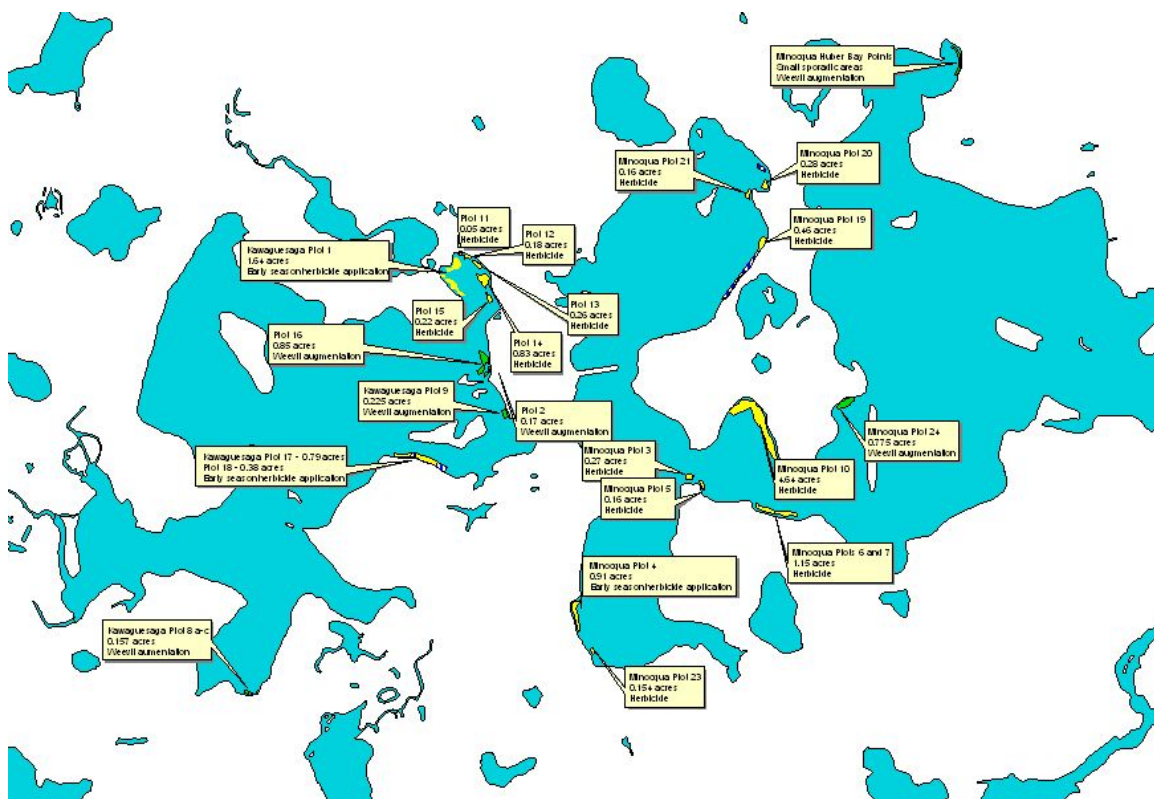
Any plot that has consistent density of 2 or higher throughout, has a defined boundary, and is navigable to map (or 400 sq ft or more), will be considered for herbicide application. The plot will be surveyed following the pre-treatment protocol outlined by the Wisconsin DNR.

Figure 57: EWM locations with treatable beds-verified Sept. 2008

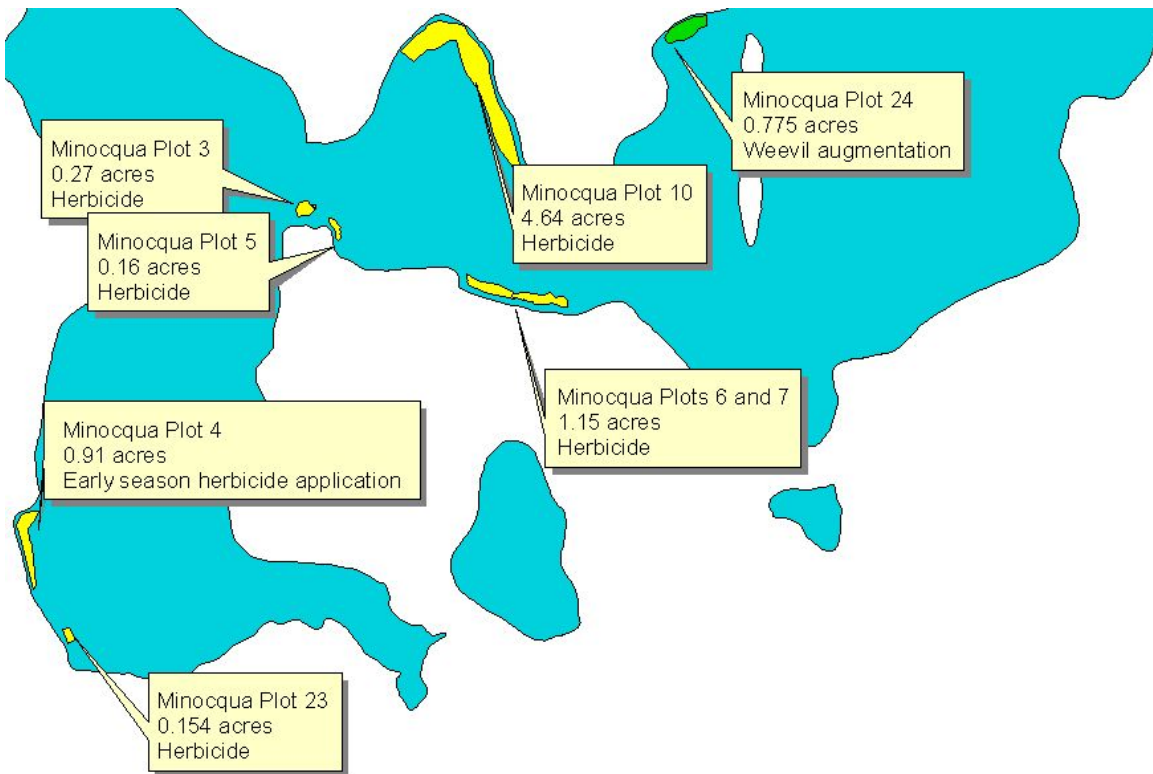
**Figure 58: Map of EWM plots 3,5,6,7, 10, 23 and 24-Minocqua Lake**

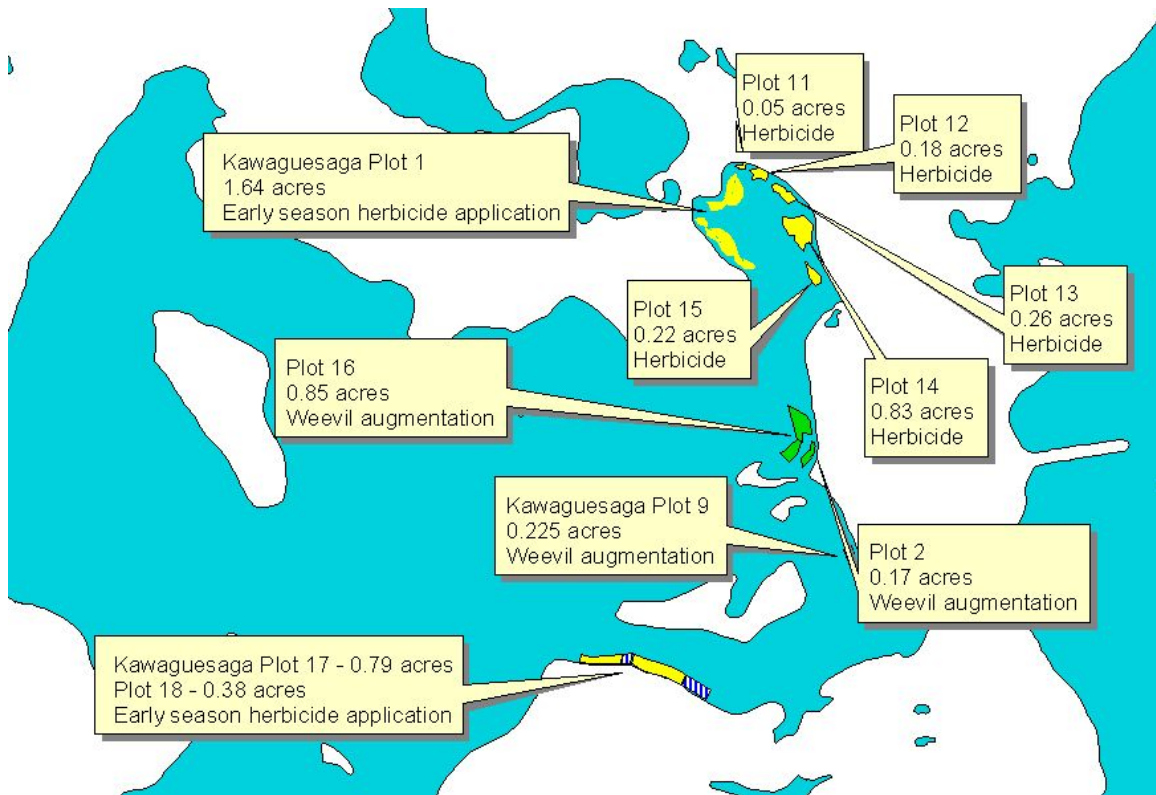
Figure 59: Map of EWM plots 1,2 and 11-18-Kawaguesaga Lake

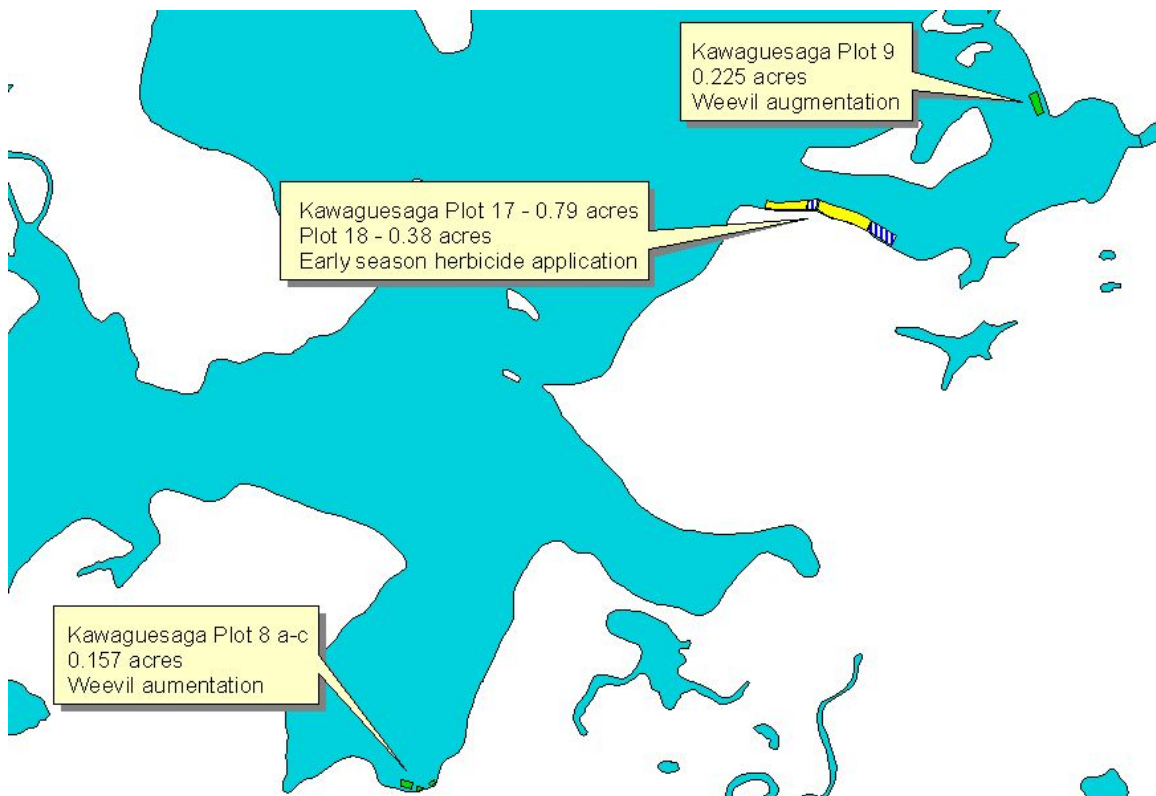
Figure 60: Map of EWM plot 8, 17, 18 and 9-Kawaguesaga Lake

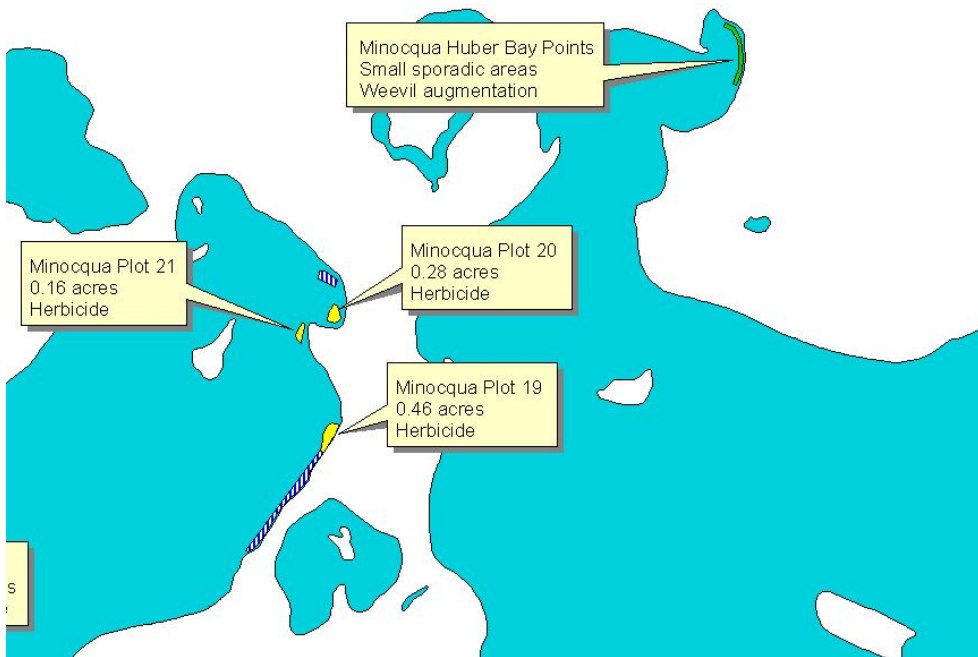
Figure 61: EWM plots with treatment type 10-21.

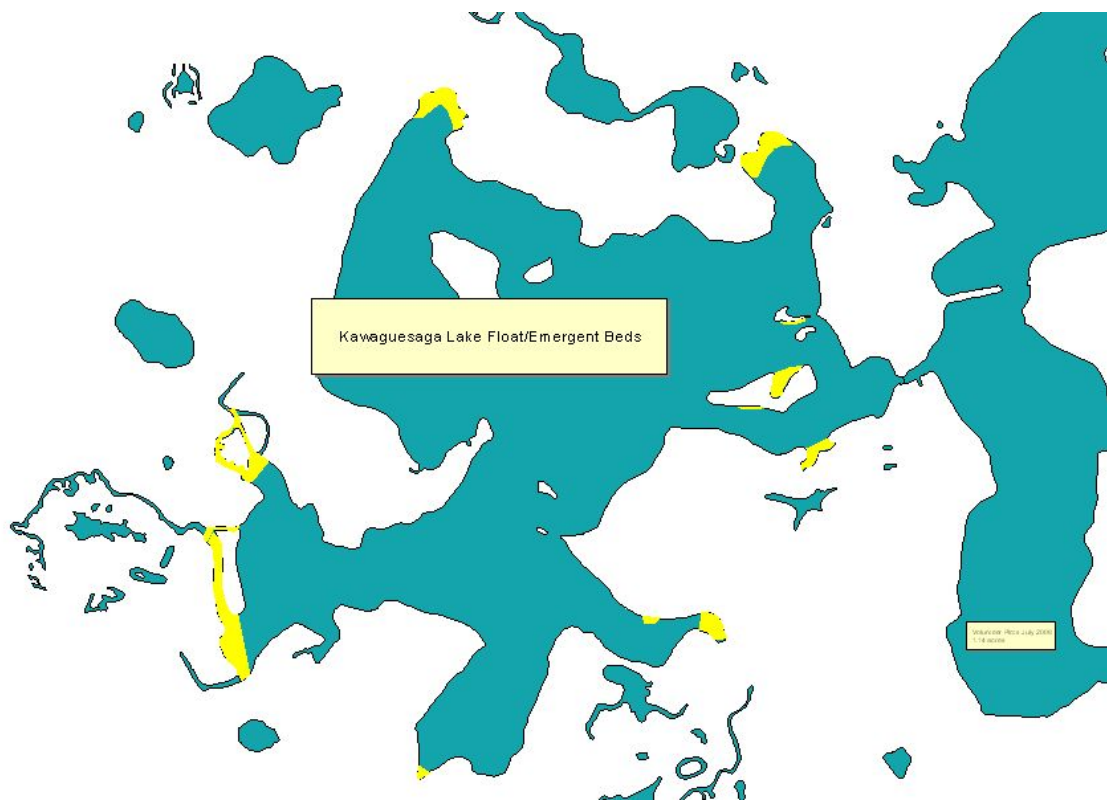
***Figure 62: Map of floating-leaf and emergent plant areas in Kawaguesaga Lake.***

Figure 62 shows the areas of Kawaguesaga Lake that have floating leaf plants and where emergent plants were sampled. These areas provide important fish, wildlife and bird habitat. Every effort should be used preserve these important areas. These efforts could include educating residents and lake users about their importance and the need for preservation and to avoid herbicide applications in or near these areas. Although a sensitive area survey has not been conducted, the areas highlighted in Figure 62 would be a good start for sensitive area designation.

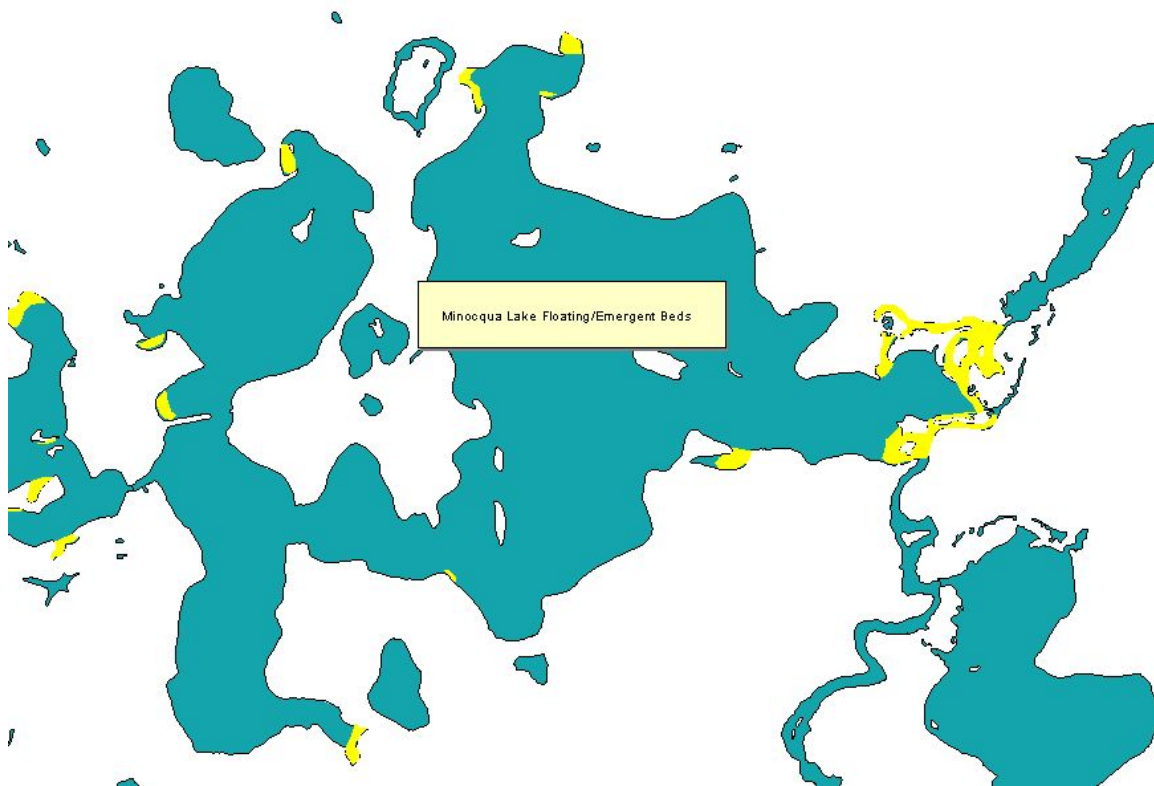
***Figure 63: Map of floating-leaf and emergent plant areas in Minocqua Lake.***
